Re: Notice of Violation  
Compliance Evaluation Inspection  
WID057163941

RCRA COMPLIANCE EVALUATION INSPECTION REPORT

**SITE NAME:** Henkel Corporation

**DATE OF INSPECTION:** May 26, 2015

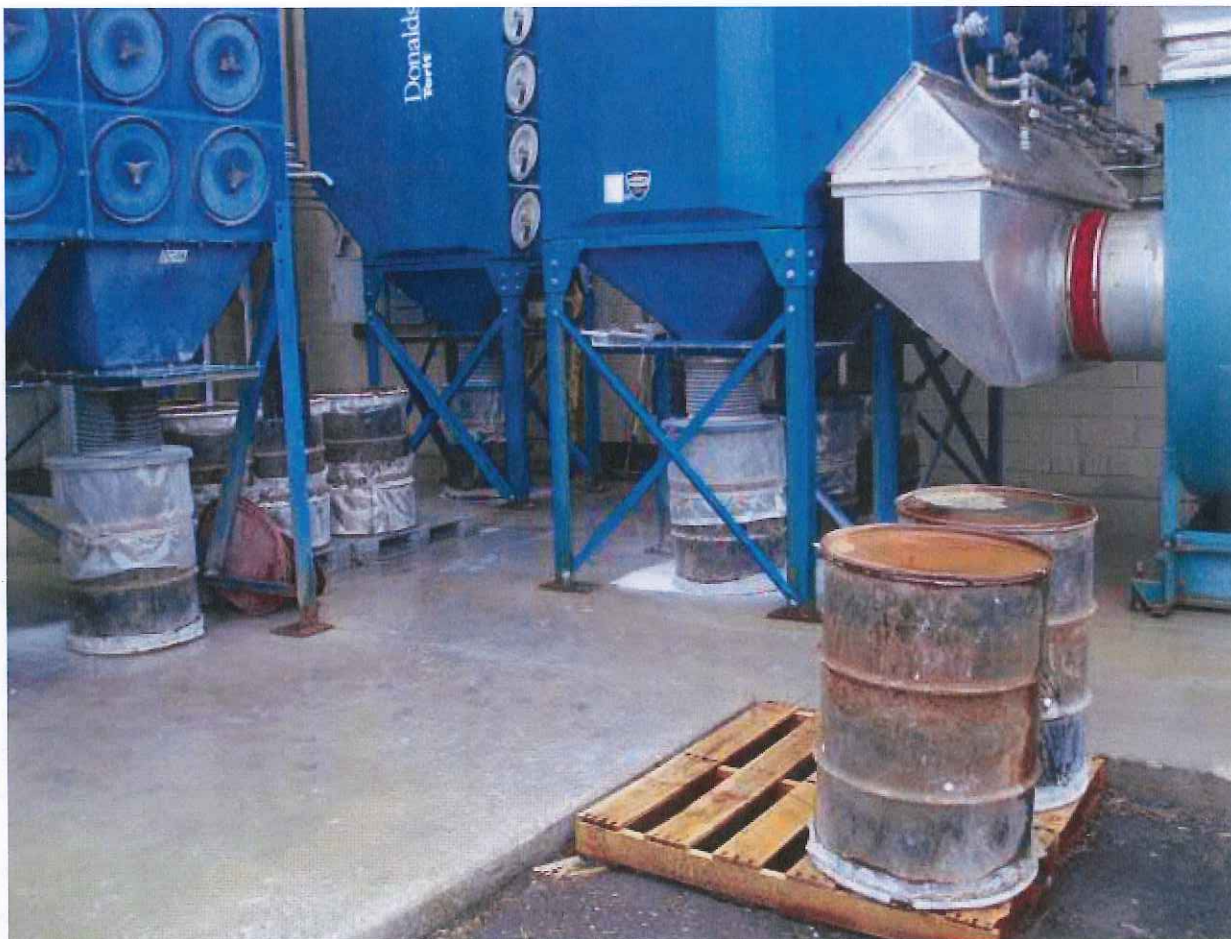
1. A view, outside at the dust collector system, of 55-gallon drums (on pallets) that contained the waste dust, and empty 55-gallon drums (on pallets) to be utilized in the system.

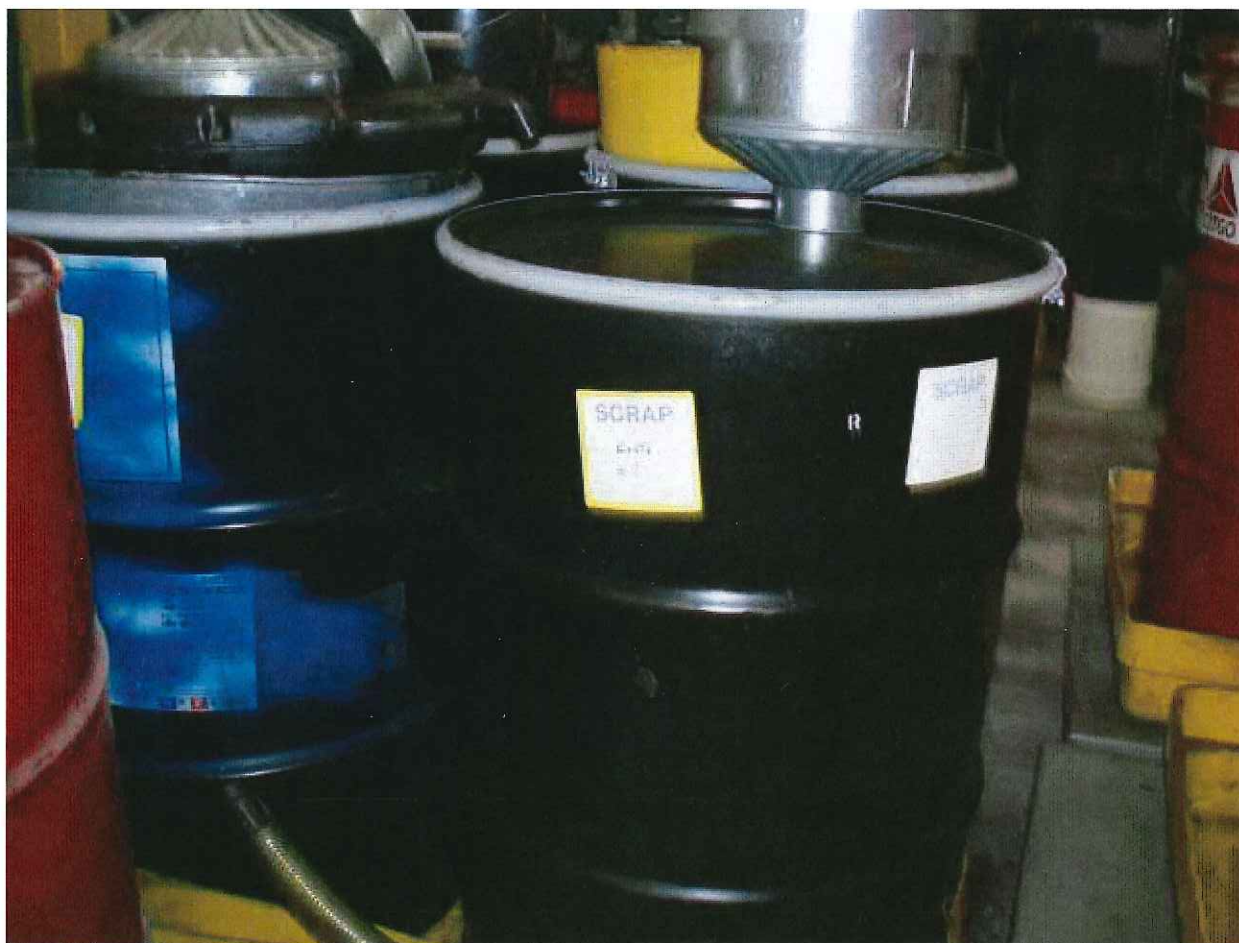
During the inspection of the Main Production Hot Melt Area, there were four 55-gallon drums that were situated on a pallet. All four drums contained used oil as stated by Mr. Schultz. All four drums were labeled as "Waste Oil and Scrap." The four drums were not labeled with the words, "Used Oil."

2. A view, at the Main Production Hot Melt Area, of four 55-gallon drums that were situated on a pallet. All four drums contained used oil as stated by Mr. Schultz. All four drums were labeled as "Waste Oil and Scrap."

After the inspection, as documented in a June 1, 2015 email to EPA, you took certain actions to establish compliance with the above used oil requirement. Based on the information received from Henkel on June 1, 2015, EPA is not planning additional enforcement actions based on this inspection at this time. This letter does not limit the applicability of the requirements evaluated, or of other federal or state statutes or regulations. EPA appreciates Henkel's cooperation.

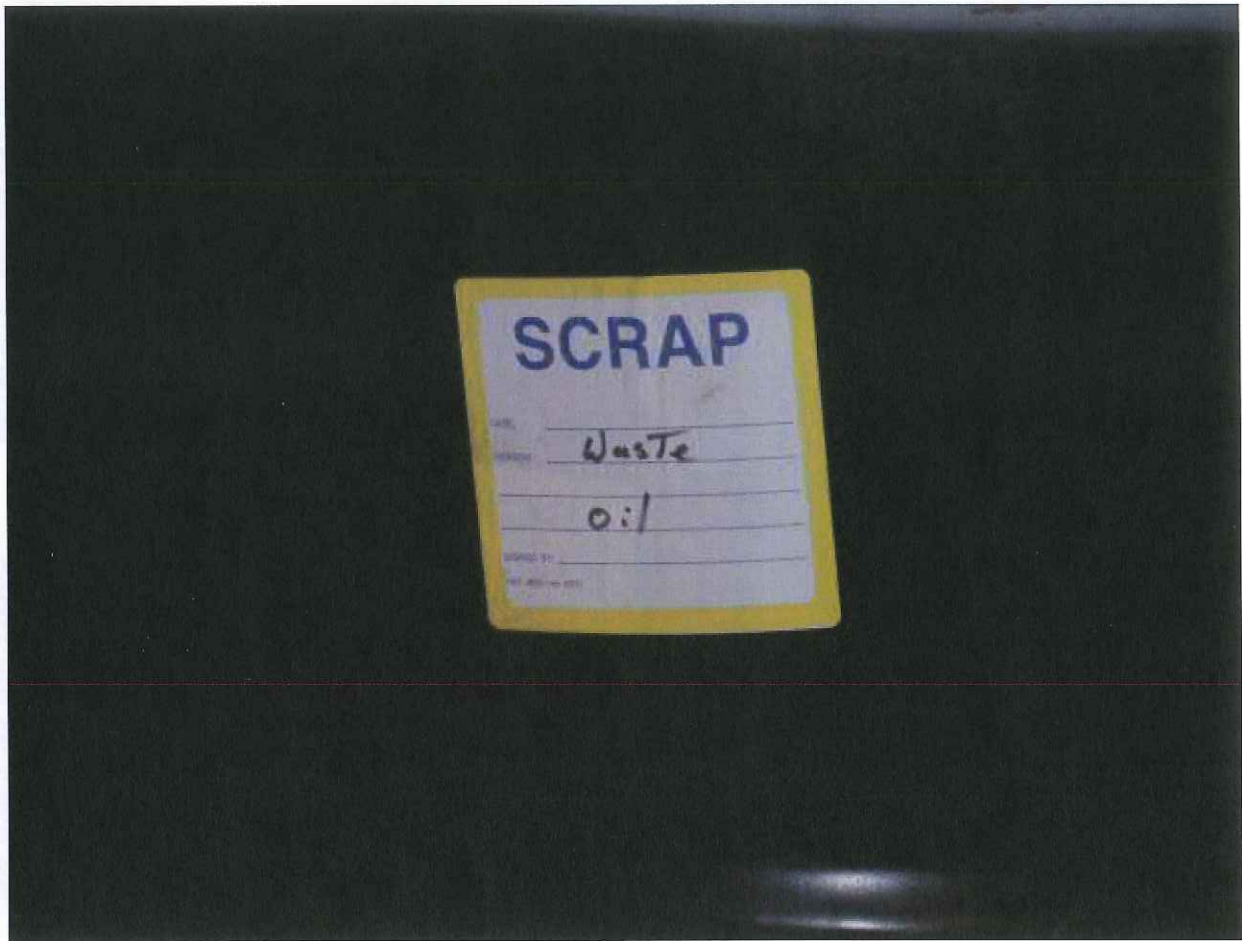
3. A view, at the Main Production Hot Melt Area, of a label on one of the same four 55-gallon drums as in photo # 2. All four drums contained used oil as stated by Mr. Schultz. All four drums were labeled as "Waste Oil and Scrap."

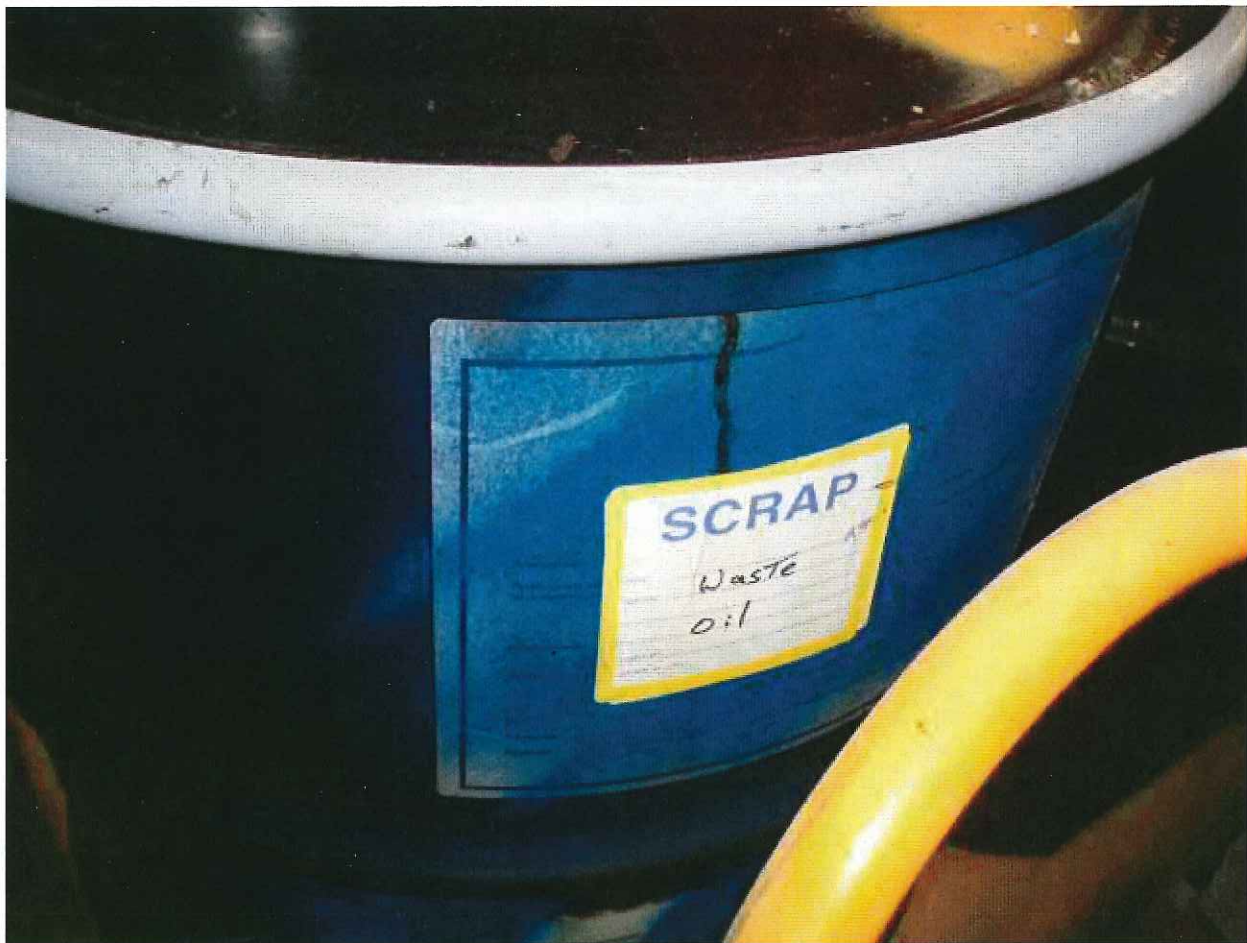
4. Another view, at the Main Production Hot Melt Area, of a label on one of the same four 55-gallon drums as in photos # 2 and # 3. All four drums contained used oil as stated by Mr. Schultz. All four drums were labeled as "Waste Oil and Scrap."
